## **MANAGING STATE LANDS FOR WILDLIFE**

### **Stream Crossings**

### **Mascoma WMA (Canaan)**

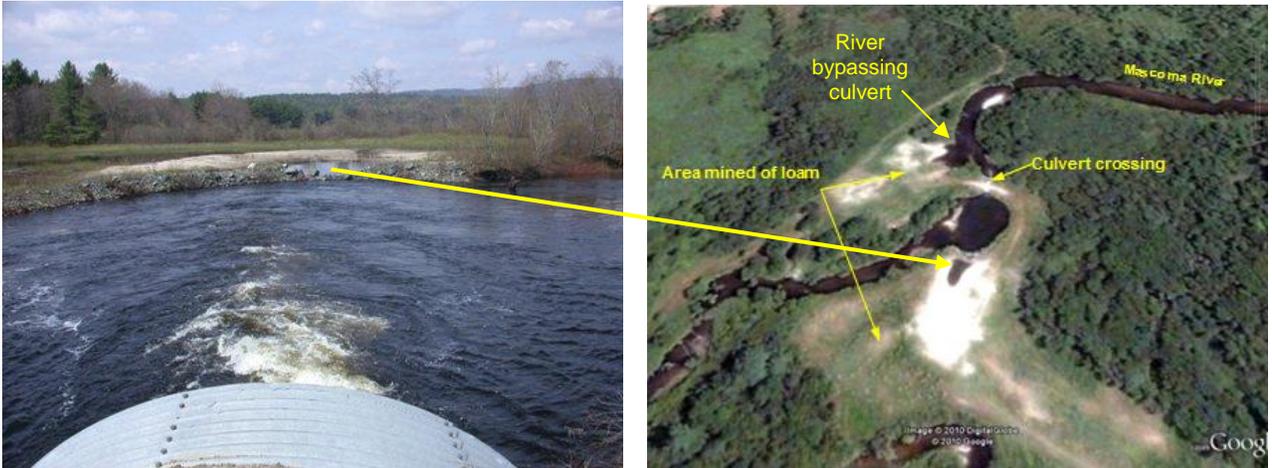
This property contained a 15 foot culvert used to cross the 60-80 foot wide Mascoma River that bisects the property. The culvert was installed by the former landowner. The constriction caused by the culvert led to significant riverbank erosion both up and downstream, forced the river to change course, and deterred fish passage. This situation was rectified in July 2011 when the culvert was removed, and the river bank restored and stabilized. Considerable work went into obtaining funding, designing the project, getting permits, contracting, and overseeing on-the-ground work. Funding for this project was provided by NRCS' Wildlife Habitat Incentives Program, USFWS Wildlife Restoration funds, and NHFG's Habitat Account.

*This undersized culvert on the Mascoma River created a water cannon effect causing considerable erosion along the river bank downstream (above). This culvert was pulled and the streambank restored this summer (below).*

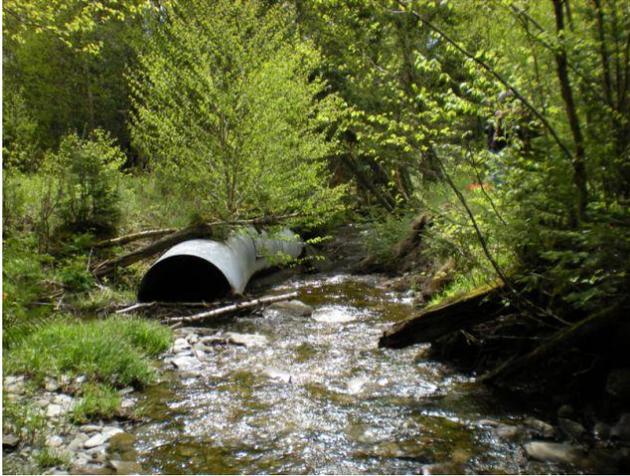
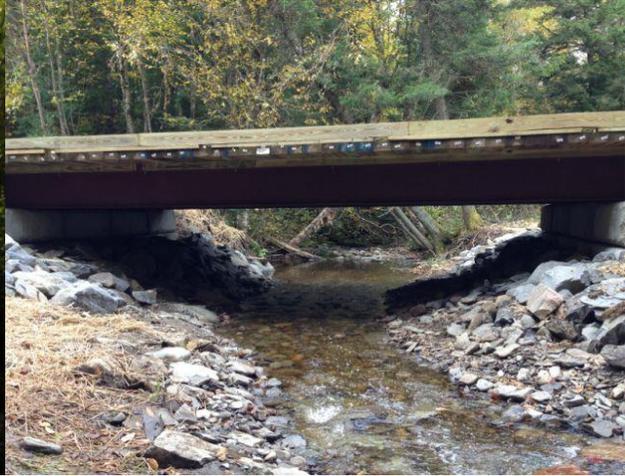
*Before (left) and after (right) pictures of streams crossings at Indian Stream (top) and Perry Stream (bottom). The new bridges will provide long-term management and recreational access while still allowing passage of fish and other aquatic organisms. Jill Kilborn photos.*

Two new bridges were installed across Indian Stream and Perry Stream in the summer of 2013. These two bridges replaced two degraded and undersized bridges on main access roads. NRCS designed and provided significant funding for these bridge projects, which will provide long term access for forest and habitat management, and public recreation. Both bridges were designed to meet 100 year flows and to ensure adequate aquatic animal and fish passage. Since then three other stream crossings on the CLNA also saw major upgrades.
